Lettre-Service

No. 1692-67-04

SUBJECT: **Reminder concerning the YAW axis control for all helicopters**
in some flight conditions

The technical comments in this Service-Letter apply to **main rotors rotating anticlockwise when seen from above**. For rotors rotating clockwise, see Service-Letter No. 1673-67-04.

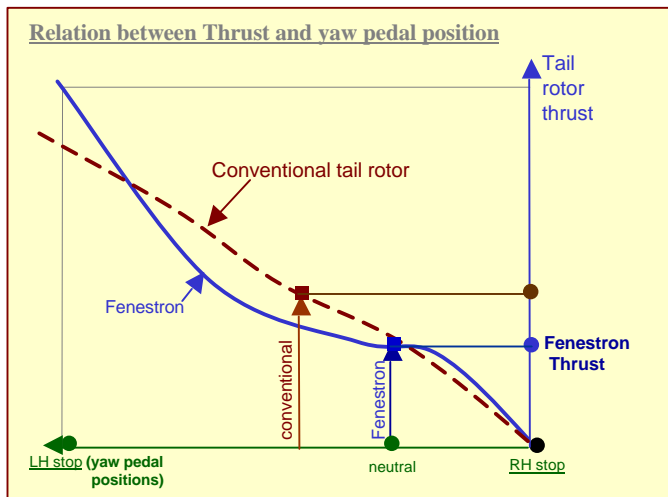
Yaw pedal position in cruise flight

In cruise flight, the **conventional rotor** delivers a thrust which comes in addition to its vertical stabilizer profile effect, so as to maintain zero sideslip.

As regards the **Fenestron**, since the fairing effect is higher due to its large surface, the thrust to be applied by the tail rotor is lower.

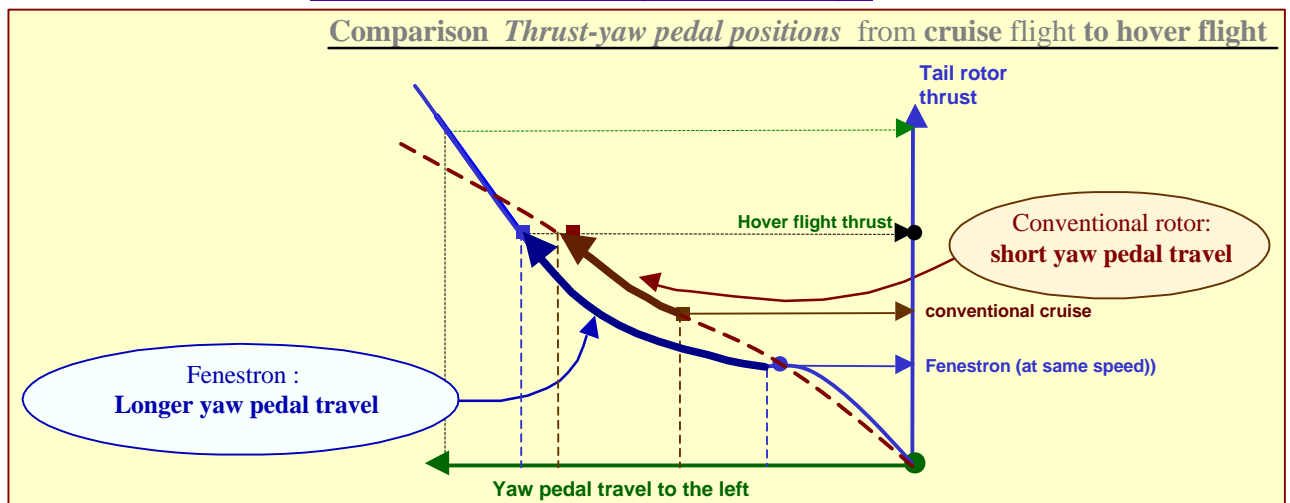
Transition from cruise flight to hover flight

With a Fenestron, when changing from **cruise flight to hover flight**, be prepared for a **significant movement of the foot to the left**.

Insufficient application of pedal would result in a rightward rotation of the aircraft during the transition to hover.
